#### URGENT ATTENTION!!! FOUND BY ED in FL!

Bed light on ALL SSR's is subject to BURN catch FIRE!!

Yes, Bed light OVER fused!

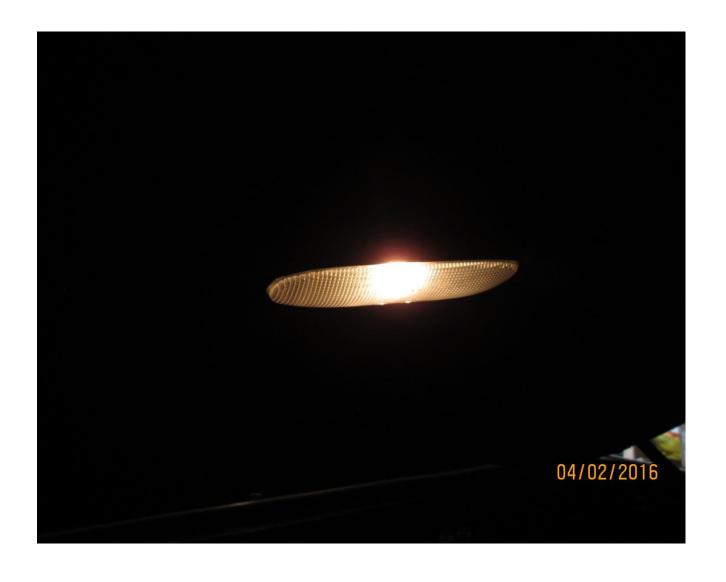
Bed light bulb is 3 amp.

Fuse 03/04 is 15 AMP! Fuse 05/06 is 10 AMP!

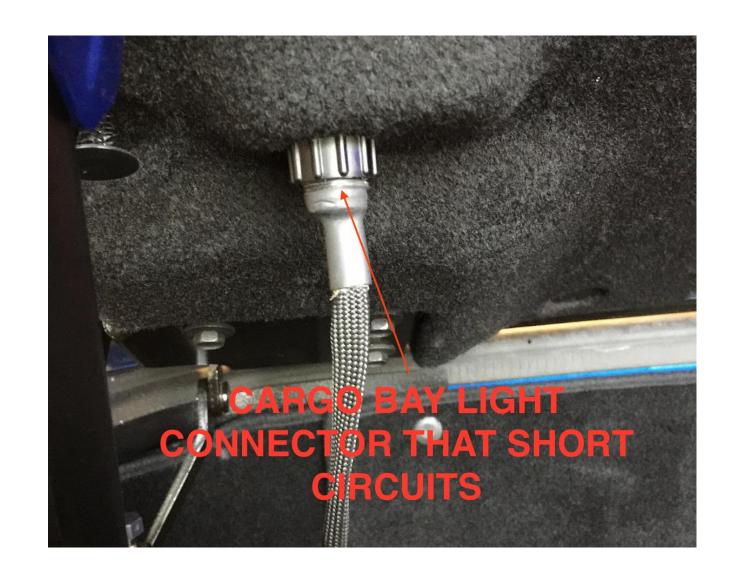
Check connector on bed to see if it shows signs of damage.

PC board with relay.

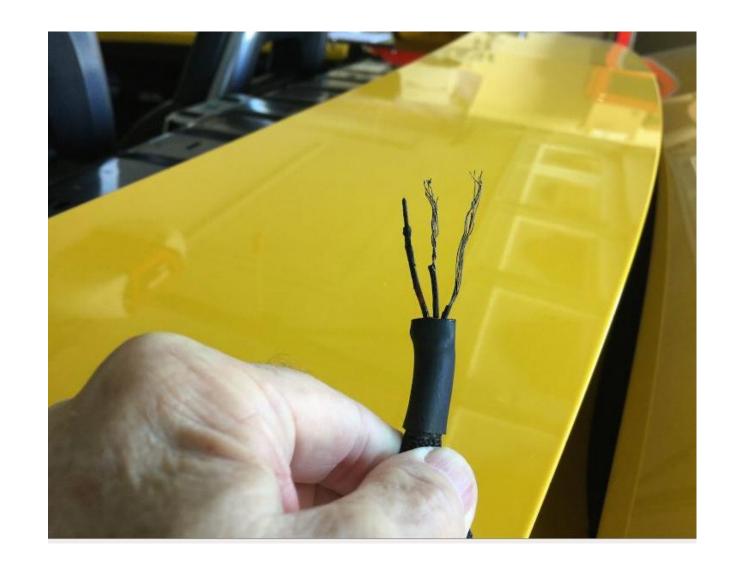
Three wires go into Bed Cover connector.

One for power

**One for ground**

**One for Body Control Module**

These are result of FIRE!

Short can take out Body Control Module.

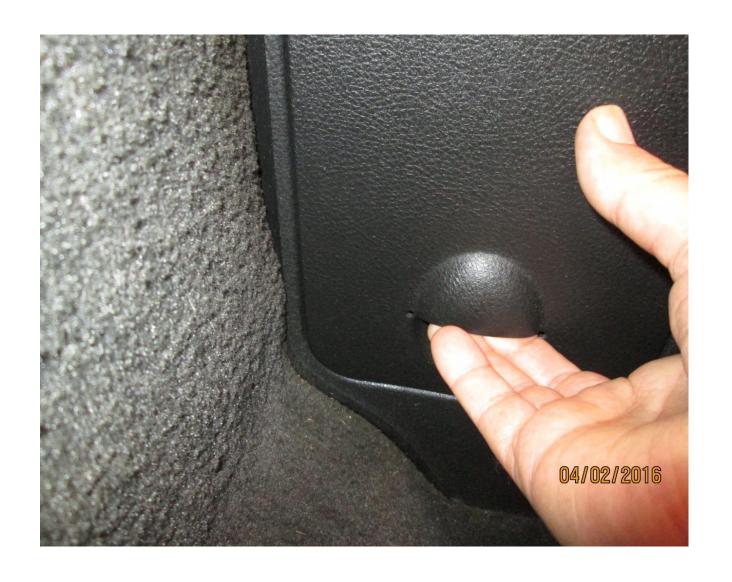
Outer cover for Passengers side fuse box.

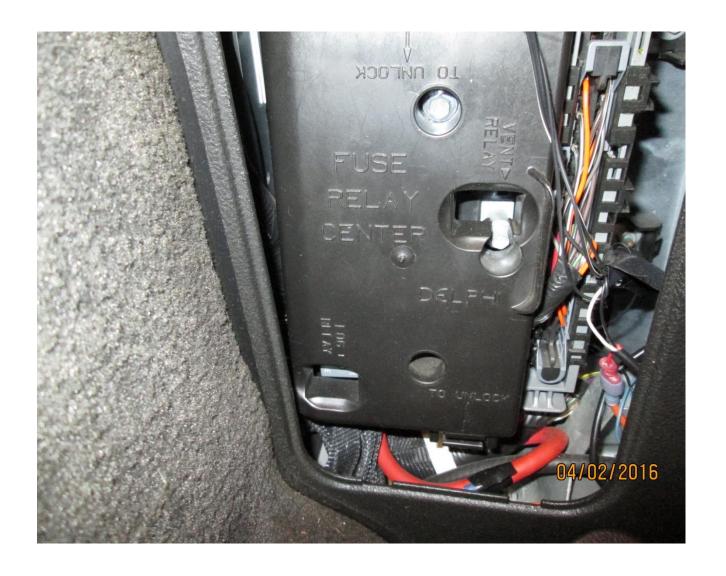
Inside cover for passenger side fuse box.

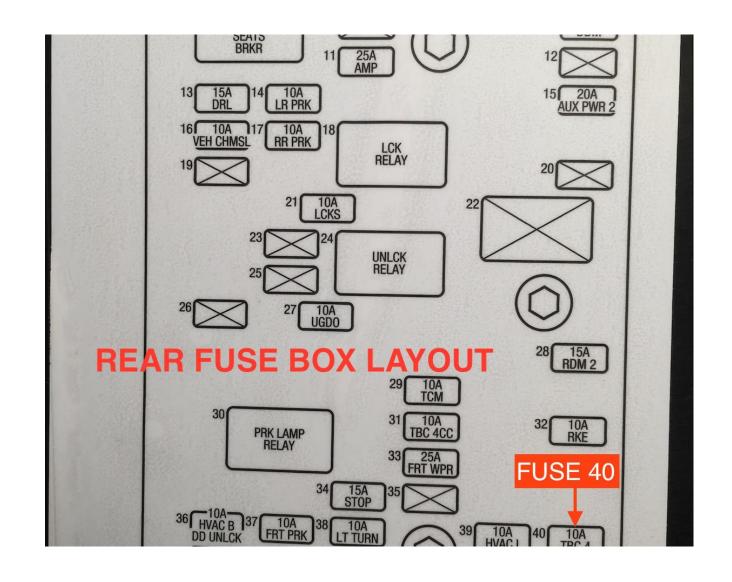
Use Fuse Box cover to locate fuse #40.

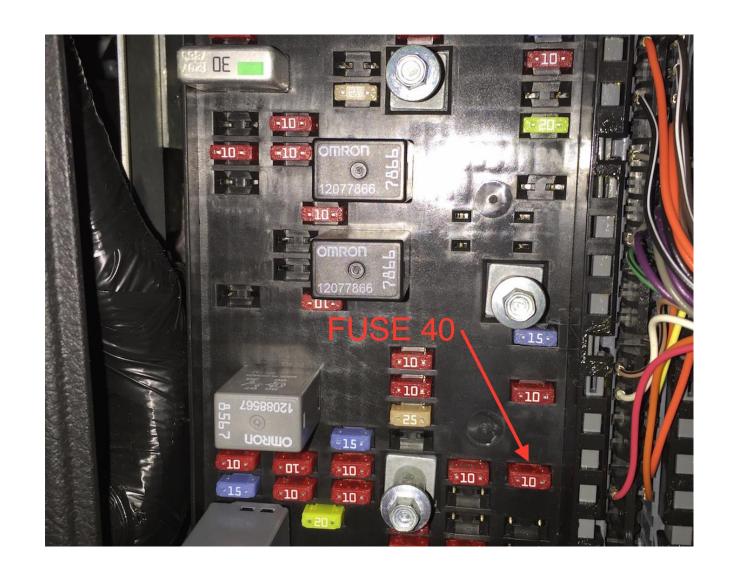
Fuse Box behind passenger seat.

Remove covers to fuse box.

Locate fuse #40 Diagram on back of fuse box cover.

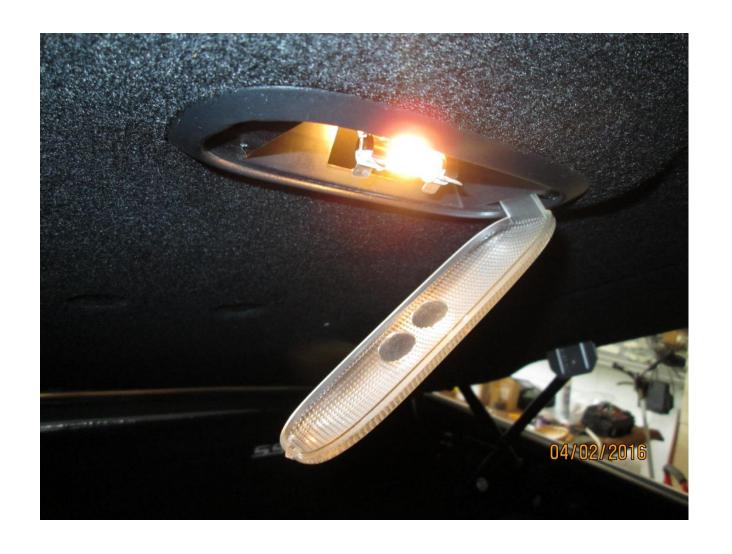
**VERY HOT!!**

**Remove Bulb.**

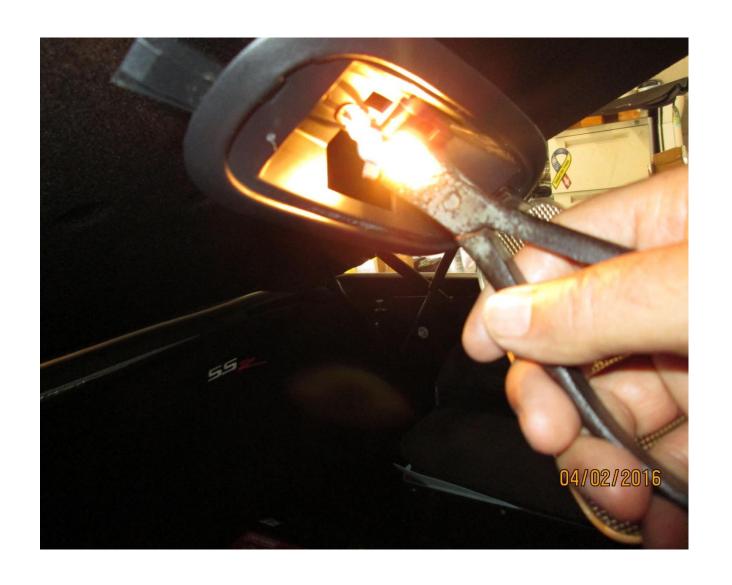
**VERY HOT!!**

**Remove Bulb.**

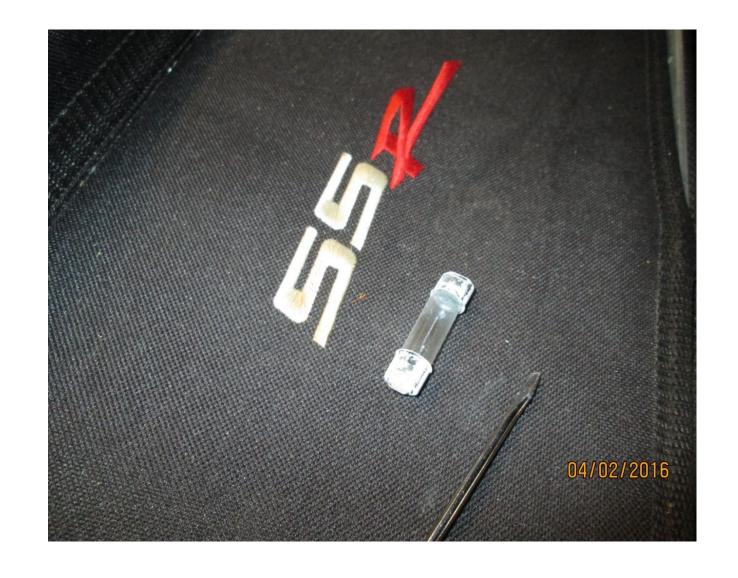
**Corrosion on Bulb.**

May lead to overheating.

May cause PC board to overheat and short out.
